REPORT ON DISTRICT NO. 1 SCHOOLHOUSE HEAD CHAPEL

PLEASANT STREET
HOOKSETT, NEW HAMPSHIRE

James L. Garvin
May 23, 2004

This report is based on a brief inspection of the building on the afternoon of May 20, 2004. The purpose of the inspection was to assess the general condition of the building and to make recommendations for its care and rehabilitation by the Hooksett Heritage Commission.

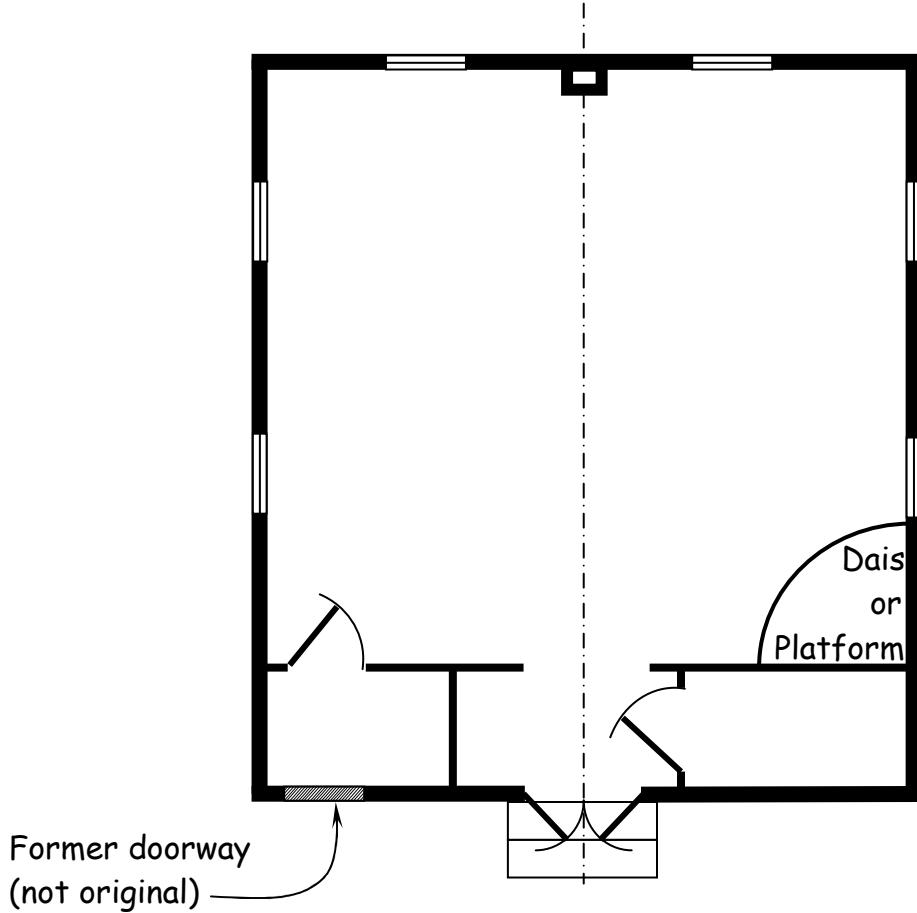
The interior of the building has a front entry that leads through a former cloakroom area to a single meeting room. A floor plan, not to scale, is given below.

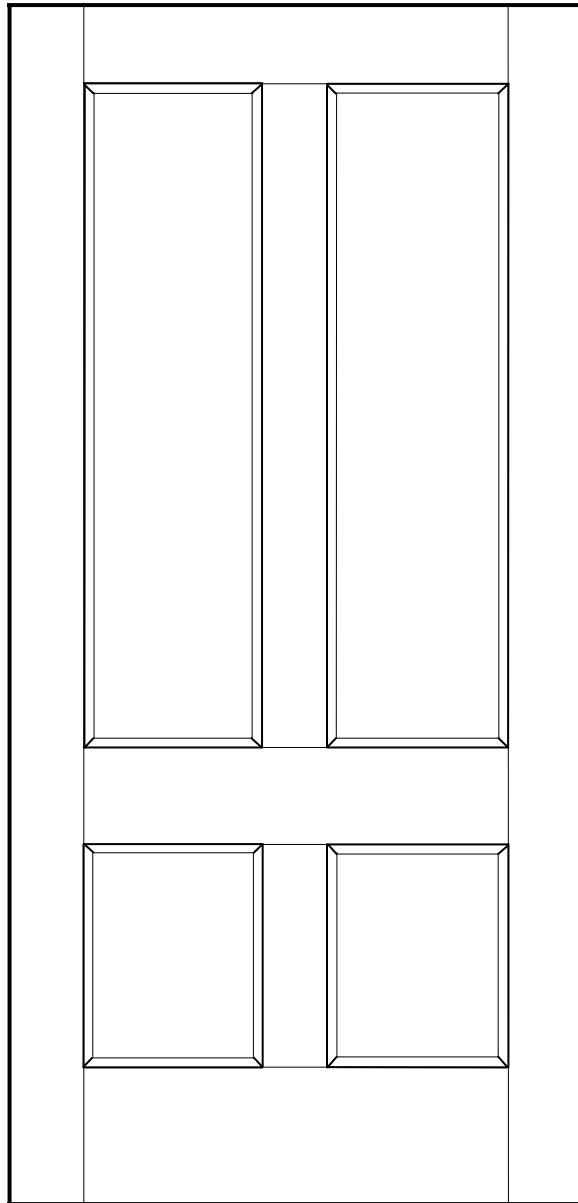
The door that now separates an office in the northern cloakroom from the entrance foyer displays the same late-nineteenth-century style as the interior door that originally led from the schoolroom to the second entrance. The first-mentioned door was originally an exterior door that once had a lock and bears clear signs of weathering on one face. It is likely that this door was originally installed in the new second entrance and that these two doors, identical in style and aligned with one another as shown on the floor plan above, were installed at the same time. The general pattern, and the stile and rail profile, are shown below.
