## ARCHITECTURAL ANALYSIS OF THE PLUMER-JONES HOUSE AND TAVERN

JANUARY 31, 2012

**Summary:** This report is based on an inspection of the Plumer-Jones Farm buildings, components of the New Hampshire Farm Museum, on January 18, 2012, and on examination of a series of detailed photographs taken to record details of the buildings and shared by Preservation Company.

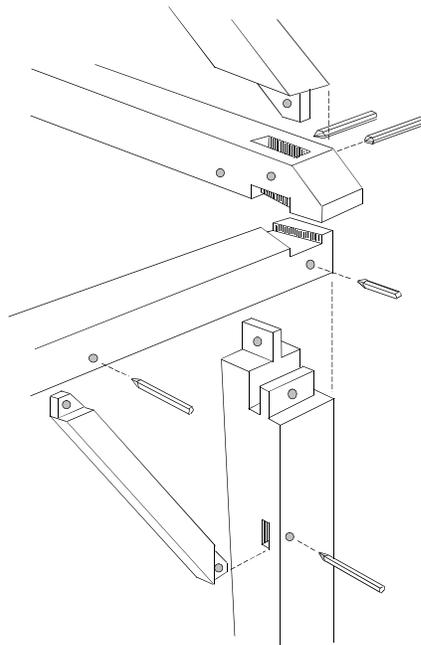
The stable has an unusually heavy and well-built frame. It retains many of the characteristics of an eighteenth-century barn, including the use of the traditional complex English framing joint at the top of the posts:

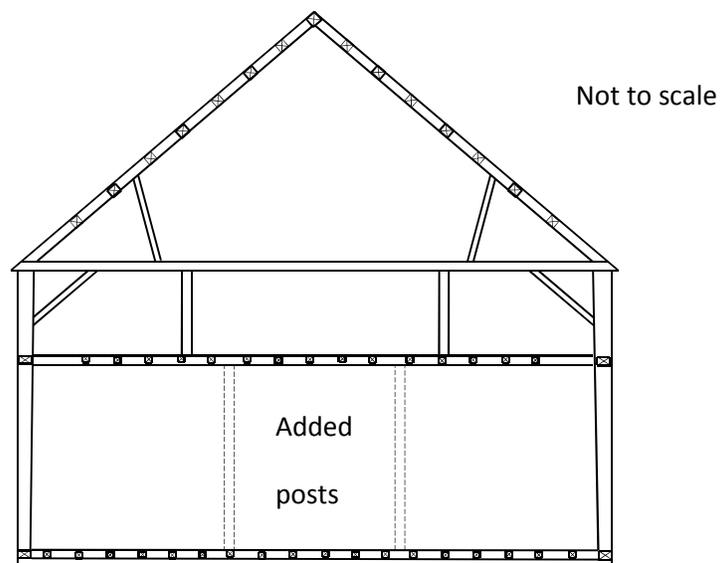
The feature that most strongly identifies the building as a stable is seen in the loft. Study of the roof framing discloses that the two tie beams that extend across the building at the feet of the two inner sets of rafters were utilized to support the loft floor, obviating the need for the heavy interior posts that characterize an English barn. Each tie beam is provided with two vertical wooden tension members that are tenoned into the ties and the loft floor beams below the ties. By this means, the loft floor was supported from above, leaving the ground floor unencumbered by posts (posts have subsequently been added here). Slanted struts between the tie beams and the rafters above them further lock the roof system into a rudimentary truss that supports the loft floor; these struts appear to be original and to be marked with framing numerals. Additional slanted planks were later nailed to the sides of the tie beams to strengthen the system.

The use of wooden tension members instead of iron rods in the Jones stable created structural problems. The weight of stored hay on the loft floor overstressed the wedges and pins that locked the tenons into the mortises in the tie beams. Several of the tenons are partially withdrawn; the nailing of supplementary planks across the sides of these members was clearly an attempt to prevent further failure. Another deficiency of the frame of the Jones stable is its dependence on the roof system alone to support the hayloft floor below. The rafters and tie beams, connected by wooden struts, were unequal to the added stresses placed upon them. In a later stable, independent trusses would have been provided within the roof framing to support the loft floor in a manner comparable to the supplementary trusses seen in the roof system of the Jones barn, described below.

Despite its robustness and expert carpentry, the frame of the Jones stable suffered from additional problems. It appears that the hayloft floors, inadequately supported from above, progressively sagged over time. Flexure of the heavy floor beams pulled their end tenons from the wall posts, which apparently remained plumb due to their substantial dimensions and the bracing effect of floor and tie beams at their feet and tops. Sagging of the loft floor opened a number of joints between floor beams and posts, which were later restrained by steel gussets.

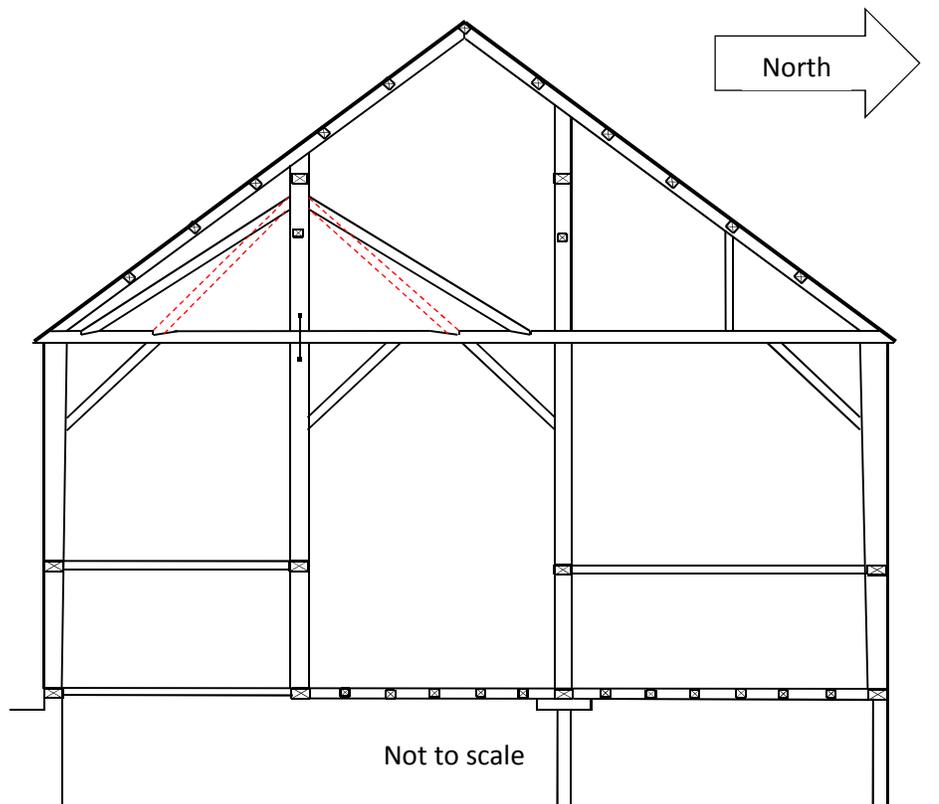
The structural system of the Jones barn is unusual. Like the earlier stable, the barn uses upper framing to support a lower floor, avoiding the placement of posts below that floor. While the stable frame used the rafter and tie beams of its roof system to support the hayloft floor, the barn frame utilizes separate trusses placed within the roof system to support both the southern hayloft and the southern zone of the ground floor. This system does away with posts in the southern half of the barn cellar, providing an unencumbered area for manure storage and removal. This suspension system places the inner posts in each framing bent of the barn in tension, hanging them from the trusses as kingposts as seen in the diagram below:

One major question regarding the barn is whether its unusual structural system is original or an addition of 1865, when the barn was moved and placed above a newly excavated cellar. As seen today, the truss system takes advantage of the higher grade to the south, supporting the southern wall of the structure on a stone foundation constructed of massive fieldstones and gaining an unobstructed cellar below the suspended kingposts.

As shown by the dashed red lines in the cross-section of the barn, there is evidence of an abandoned truss system of a similar nature in the tie beams of the barn. If the now-empty
