REPORT ON THE OLD PARSONAGE NEWINGTON, NEW HAMPSHIRE

JAMES L. GARVIN
OCTOBER 22, 1999

This report is based on an inspection of the Old Parsonage on the afternoon of October 19, 1999. The purpose of the inspection was to evaluate the general condition of the building, with particular reference to moisture conditions and exterior paint failure.

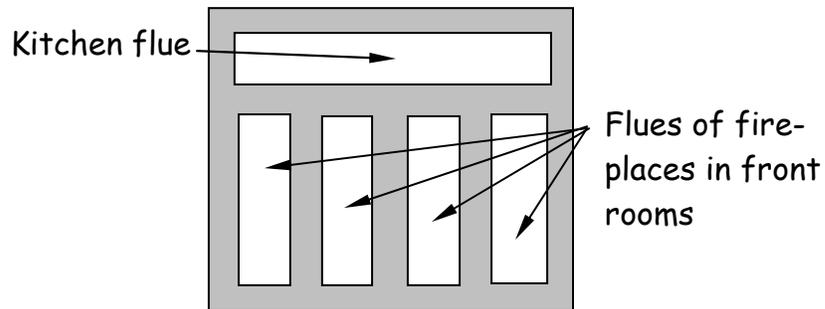
Most of the moisture that is saturating much of the chimney stack is almost certainly entering the chimney through the open flues that are exposed to rain. As seen from the top, the flue arrangement of a central chimney like that of the parsonage looks like this:

Exposed to the sky, these open flues absorb a great deal of water. When the chimney is inactive, as at the parsonage, this moisture saturates much of the masonry. The only means by which the chimney rids itself of the water is through evaporation in warm, dry weather. This evaporation is aided by convection currents that naturally rise through the chimney flues and help to carry off the moisture.

In a chimney that reveals the extreme moisture conditions seen in the parsonage, it is beneficial to exclude as much as possible of the moisture that falls into the open flues. At the same time, it is beneficial to permit the drying convection currents to continue to rise through the flues and to carry of moisture in the brickwork and also in the internal atmosphere of the rooms that are served by fireplaces.

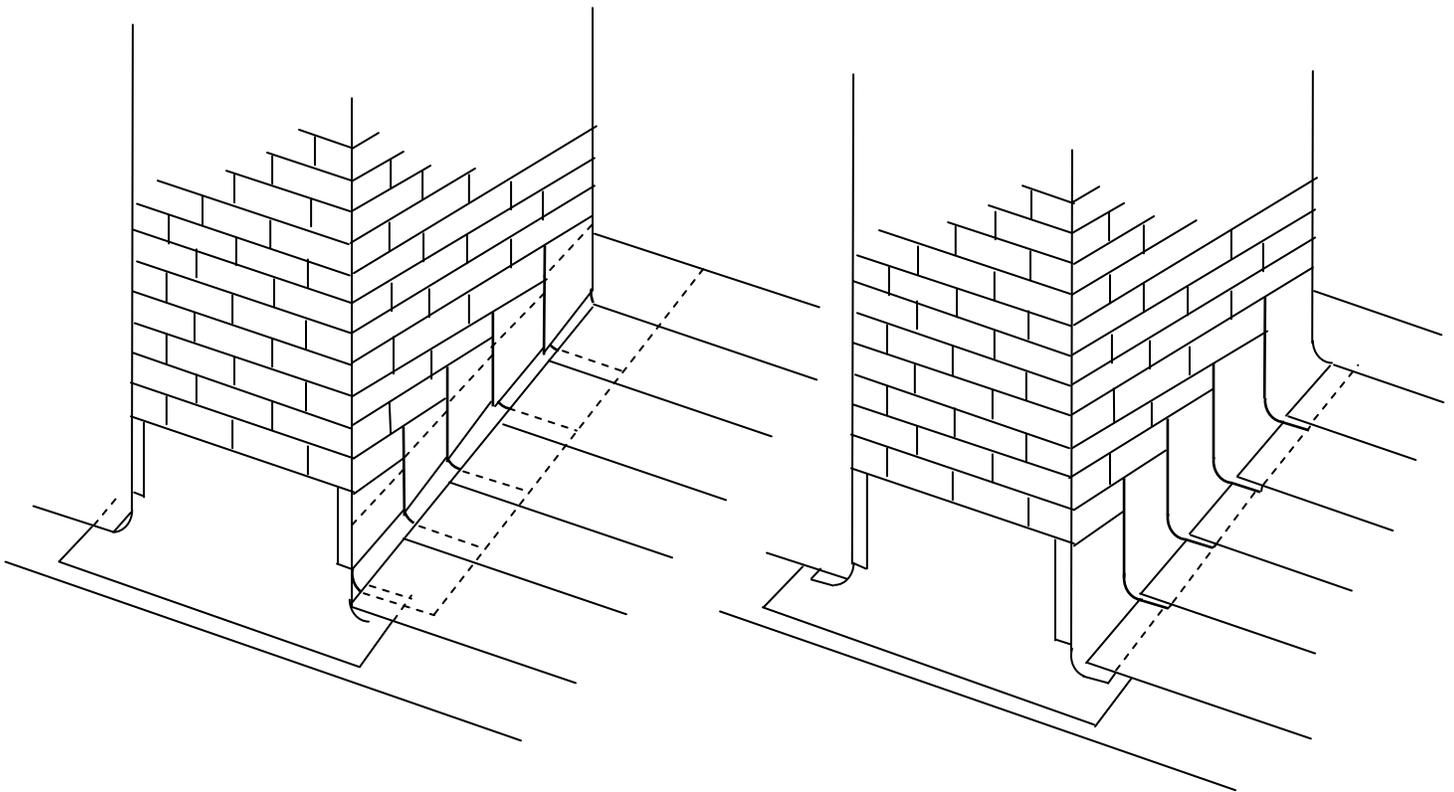
Another possible means by which water may be saturating the chimney is through the flashing at the juncture of the chimney and roof. When the present roof of asphalt shingles was installed, the lead flashing that is mortared into the joints of the chimney was simply turned down, folded out onto the roof, and interlaced with the shingles, as shown below at the right. This method of flashing, although common, is often a cause of leaks around the sides of a chimney.

Cap and base flashing
The best practice

Flashing tucked under shingles
Common but poor practice

Moisture meter readings did not prove that rainwater is leaking through the chimney flashing at the parsonage—only that the outside faces of the chimney stack are saturated with moisture. Given the propensity of this flashing method to leak, however, it would

The recommended method of flashing a projection through a roof is shown below at the left. This method uses two entirely independent systems of lead flashing sheets: cap flashing and base flashing. The base flashing is placed under each course of shingles, projecting well out onto the roof, and is folded up against the side of the chimney stack. The cap flashing, mortared into the joints of the chimney, is folded down over the base flashing, covering the vertical portions of the base flashing. This method prevents water from penetrating the juncture of roof and chimney even in torrential rains.

be prudent to require a double system of cap and base flashing when the roof is re-shingled in the future.
