### SUNCOOK VILLAGE SCHOOL PEMBROKE WATER WORKS BUILDING PEMBROKE, NEW HAMPSHIRE

**JAMES L. GARVIN  
FEBRUARY 13, 2005**

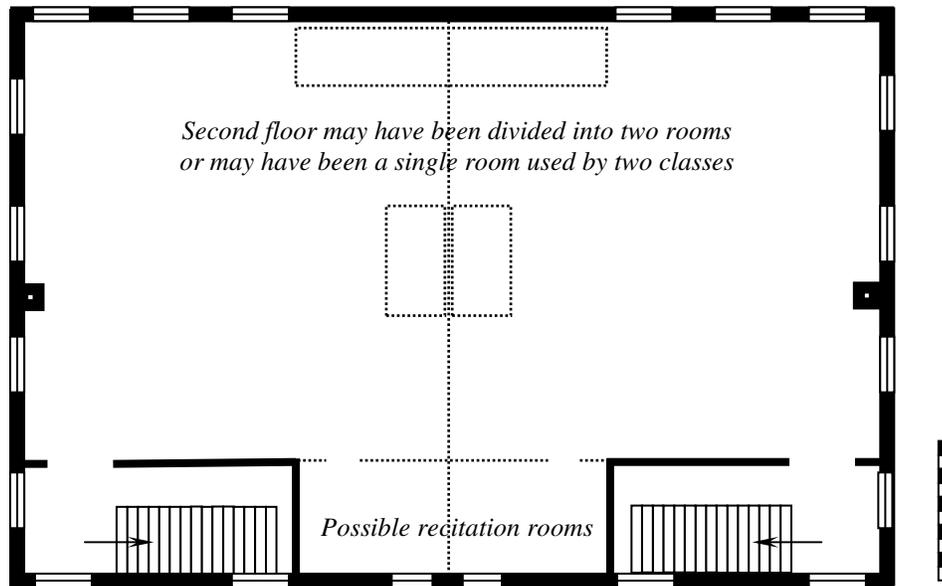
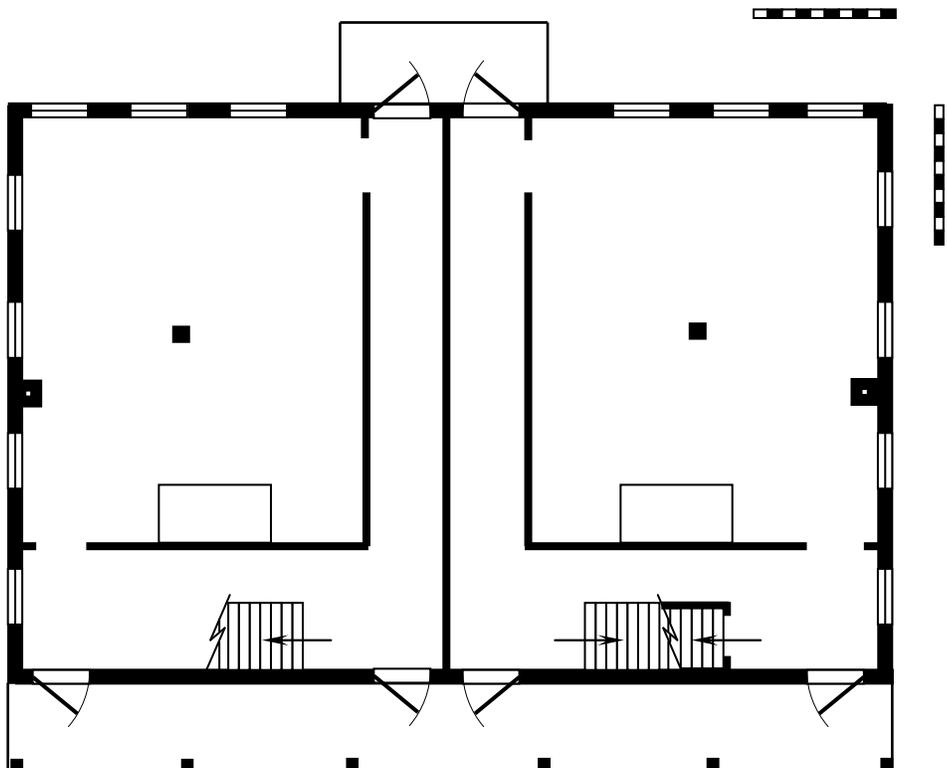
Although time has not permitted a detailed investigation of physical evidence in the building, its original floor plan appears to have approximated the following sketch:

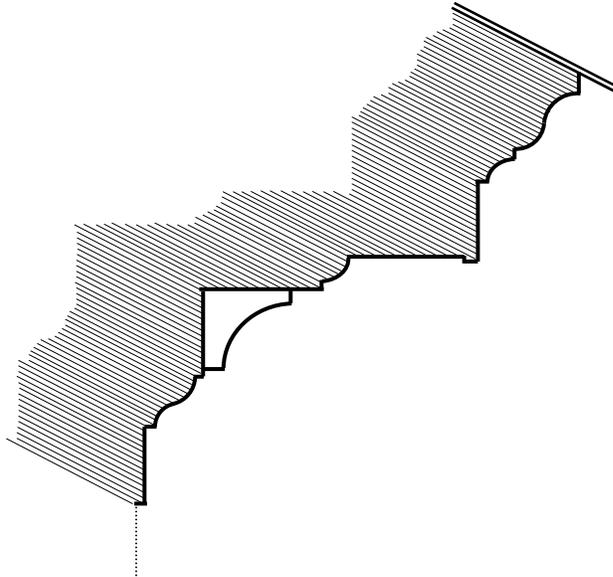
*Not to scale*

As shown by physical and photographic evidence, the exterior of the building was marked by a deeply projecting wooden cornice. This cornice remains on the front of the building and (except where damaged by fire) on the rear. As shown in early photographs, the eaves cornice originally returned along both gable ends of the building some three feet. Raking cornices of the same profile as the front and rear eaves cornices followed the roofline on each gable end. The cornice returns have been removed from each gable end of the building (exposing the wooden cleats that supported them) and the raking cornices have been replaced by flat boards placed snugly against the brick gable walls. The profile of the original cornice is as follows:

The elaborate cornice of the building was an important original architectural feature of the schoolhouse. This feature fortunately remains intact along the front of the building. Restoration of the cornice returns and the raking cornices on each gable end would greatly enhance the appearance of the structure, returning some of the visual interest of the original roofline.

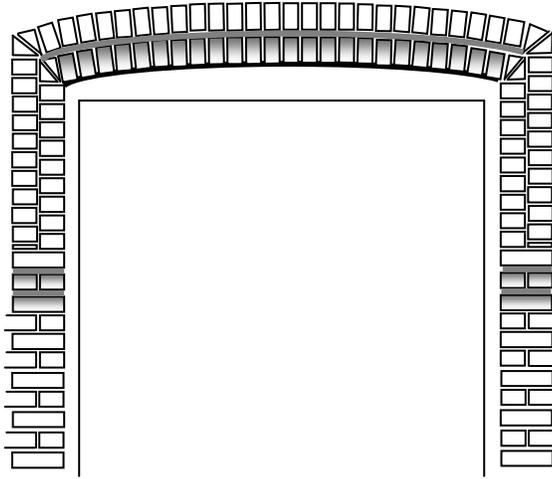
The exterior of each window and door opening of the building is covered by a projecting brick label molding fashioned by corbeling one course of bricks about four inches beyond the plane of the wall:

This treatment imparts a distinctive architectural quality to the school building. The use of label moldings is especially linked with the Italianate style of architecture, which was popular in New England from the 1850s.

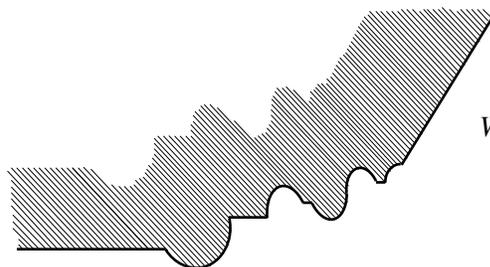
The interior of the Village School was originally characterized by plain plastered walls, by wooden wainscoting in most rooms and corridors, and by heavy door and window casings of the following profile (not to scale):

*Window casings have splayed sides*

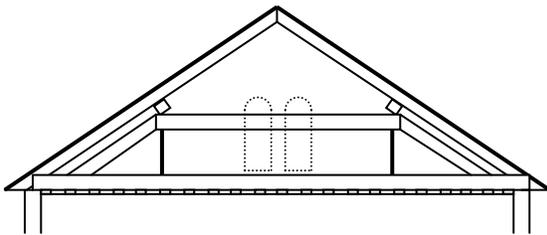
*Probable original roof truss system*

An apparent change took place on the second floor in the late 1800s or early 1900s, although we do not presently have documentation for the change. This was the raising of the ceiling of the room for gymnasium or auditorium use. Although an engineering report prepared by SW&C Engineering in May 2004 does not provide a detailed roof framing plan or sectional drawing, it does suggest that the current framing system is as shown below, at the right. Shown below at the left is the probable original design. It is likely that the original trusses spanned the building at the eaves level, allowing the attic windows to function as intended. As revealed where fire damage has caused the pressed metal ceiling panels to be removed, the current raised bottom chords of the roof trusses are nail-laminated members. By contrast, as reported in the SW&C study, the original truss members are 6” by 8” solid timbers.
