NEW HAMPSHIRE DIVISION OF HISTORICAL RESOURCES

REPORT ON THE HEALD HOUSE HEALD ROAD WILTON, NEW HAMPSHIRE

JAMES L. GARVIN
NOVEMBER 5, 1999
COMPLETED SEPTEMBER 1, 2002

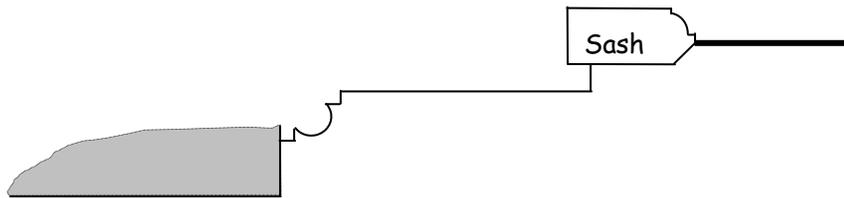
The staff mouldings at each window follow this general pattern:

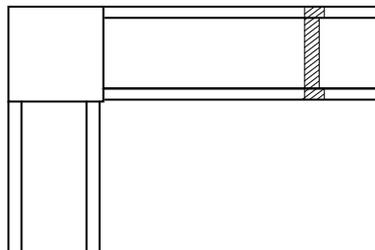
The fact that the Heald House was built as a transitional dwelling, with a conscious duality of style, is reflected in the front entrance of the house. Here, the front door is a six-panel unit with flat panels facing the exterior in the classic federal-style pattern. The door essentially matches the flat-paneled interior doors seen in the western rooms of the house (see cross-section, page 5). This door is flanked by four-light sidelights above panels. The front doorway is surrounded, however, by a symmetrically-moulded casing with square blocks in the upper corners of the opening in the brick wall, in this manner:

This type of casing is characteristic of the early Greek Revival style. Its use on the front entrance of the house proclaims the joiner's intention to display the new style in the most prominent feature of the building's exterior.
