### **REPORT ON THE WEEKS ESTATE LANCASTER, NEW HAMPSHIRE**

**James L. Garvin  
22 July 1992**

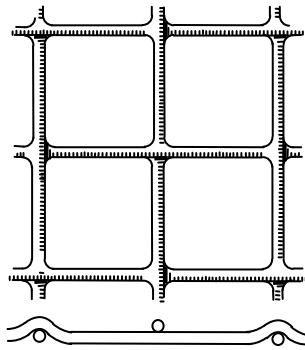
Both house and garage are covered with lime stucco applied in three coats. The walls of the house, except for the cobblestone masonry chimneys at the east and west ends, are constructed of terra cotta tiles. The stucco is applied to the grooved exterior faces of these tiles. By contrast, the garage is a framed building, and its walls are framed with two-by-four studs covered by one-inch sheathing, laid horizontally. In keeping with standard practice in stuccoing framed buildings, the sheathing is covered with tarred felt, which in turn has wooden furring strips applied to receive the lath for the stucco. The lath used here is wire mesh (hardware cloth) rather than expanded metal lath.

Woven wire lath for exterior stucco  
(not to scale)

The wire mesh of the garage, and the terra cotta blocks of the house, have received the standard three-coat covering of lime stucco. Tests made with acid on the garage stucco indicate that a small amount of Portland cement was added to the mix. A similar formula should be used in repairing the stucco.
